Introducing the HP-56 Hg Lamp for the Thermo Scientific Mercury Freedom System

April 29, 2013

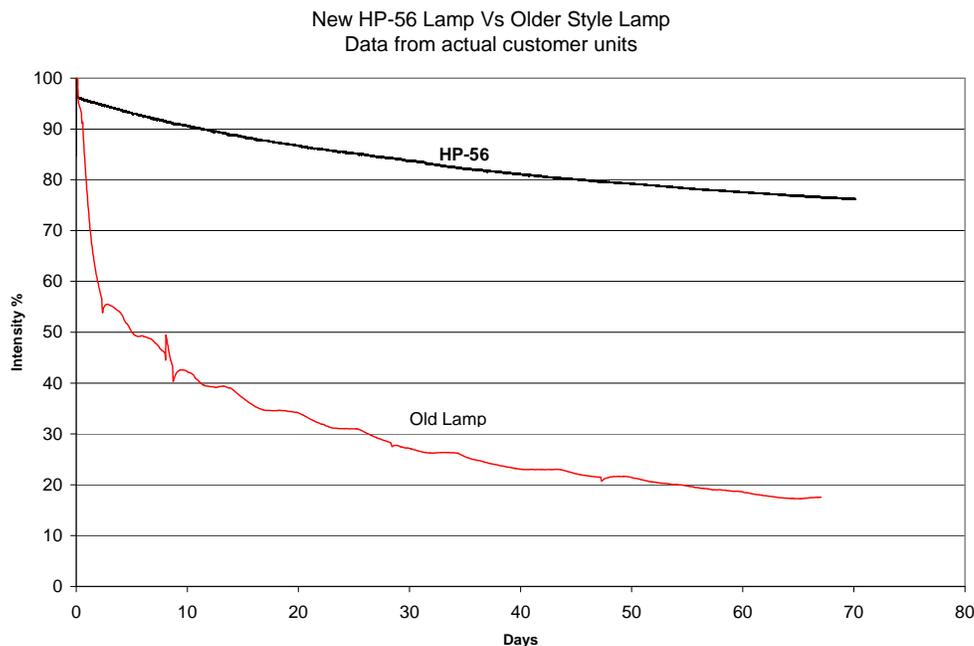
During the past year, we extensively tested the HP-56 Hg lamp at 12 field sites with strong results. The test results prove that the HP-56 Hg lamp has high operational stability and a shorter warm-up time (time to stabilization). While the light intensity from the older style lamps drifted approximately 1% per day, the light output from the HP-56 Hg lamp in the field trials only drifted on the order of 0.2% after initial stabilization (example shown in figure below). Note that the reference intensity drift is not the same as measurement drift as the Lamp Compensation feature compensates for the bulk of the intensity drift.
